Case Study

Site Description – Diesel fuel spill under railyard tracks

Site Location: Fort Wayne, Indiana

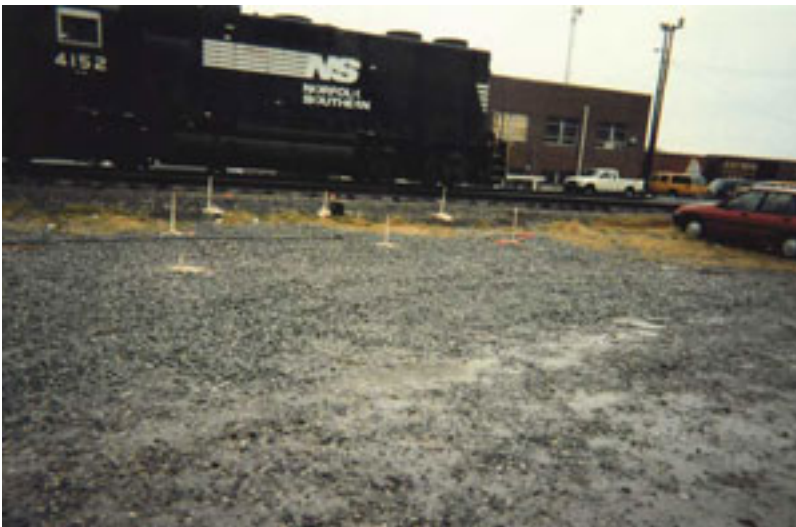
Photo 1 10 injections points allowed us to introduce the product with minimal disruptions to trains and road traffic.

To treat the area we developed a matrix that contained 10 injection points. Each of the sites had vertical holes drilled and PVC pipes were put into the hole. The 10 injection points allowed us to use pressure injection and gravity feeds to add microbes to the area.

The Oppenheimer Formula III was introduced into these sites in a slurry form. The slurry was made by mixing the formula with the BioCatalyst, no other products were used.

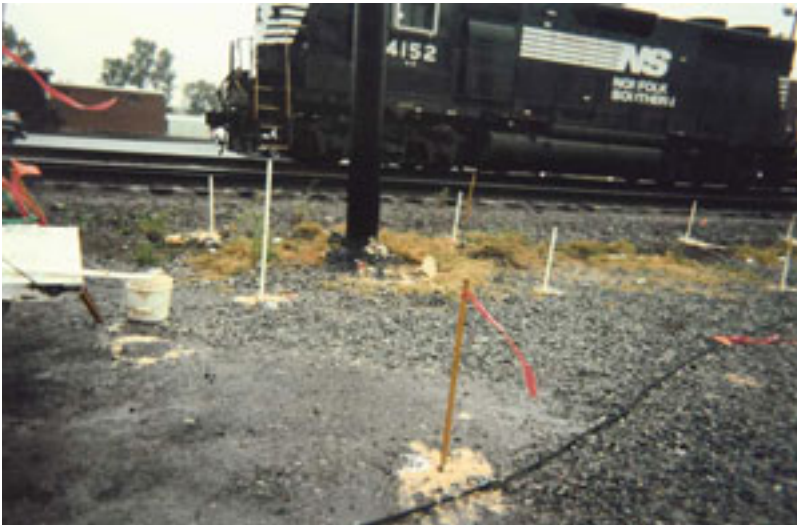
Photograph 2 Injection points within 4 feet of train tracks as trains pass by.

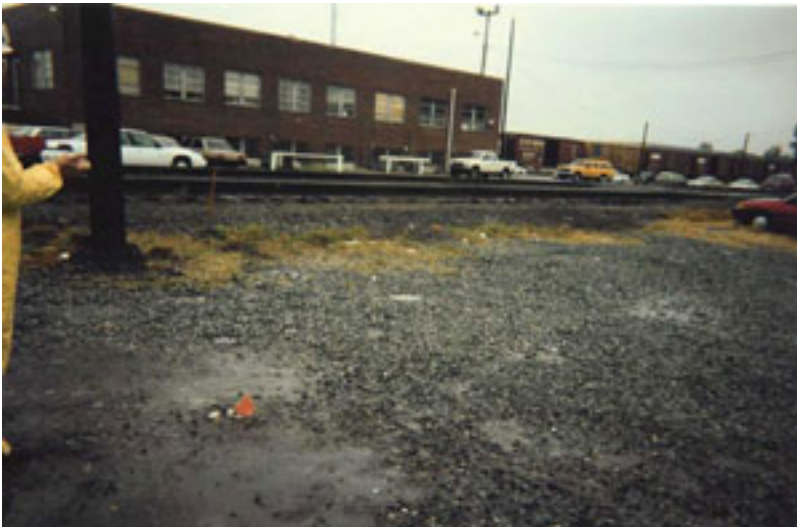
Photograph 3 After treatment the injection points were left in place but cut off at ground level.

The weather conditions during treatments were mostly raining with temperatures consistently in the mid 50's. After treatment the injection points were cutoff at ground level. This allowed us to monitor the groundwater as well as allow us to re-treat potential hot spots if they arose.
