Case Study

Site Description – Crude oil (bunker C) spill in Sea of Japan

Site Location: Mikuni, Japan

Contaminant: Heavy Crude oil

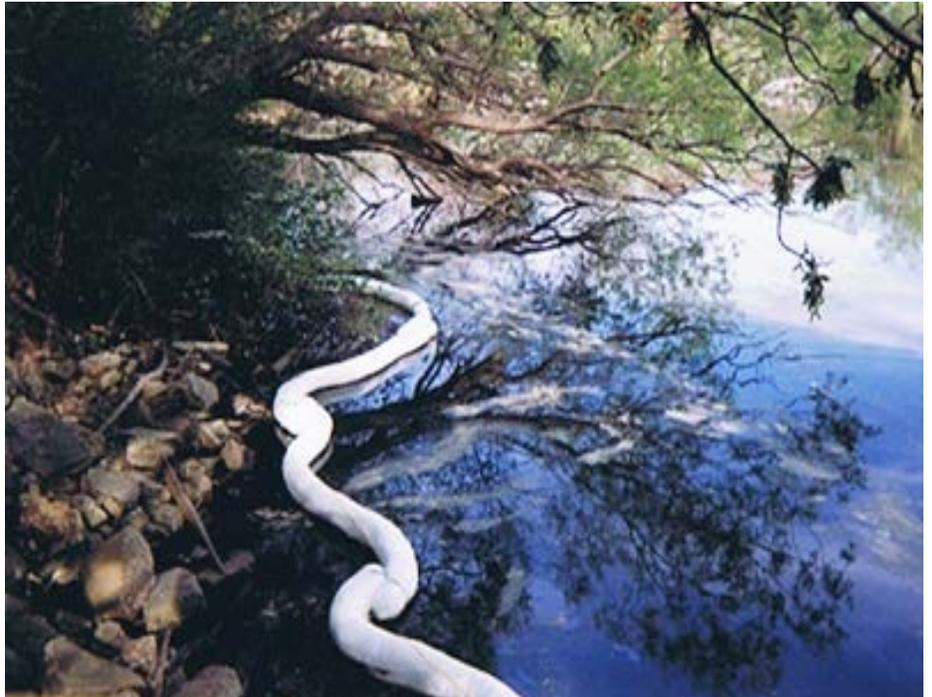
Description of area. The shore line is mountainous and rocky with an occasional small bay with coarse sand and cobble beach. The diurnal tides were approx. 1.6 meters. The area of the site is north of Osaka along the Japanese sea coast in Khyogo, the area of Kasumi, at a small village, Shibayama. The bay was protected by jetties. In front of the town, concrete ramps and piers housed the fishing boats. The shoreline was part coarse sand and rocks. The linear area of the bay edge was approximately 3/4 km.

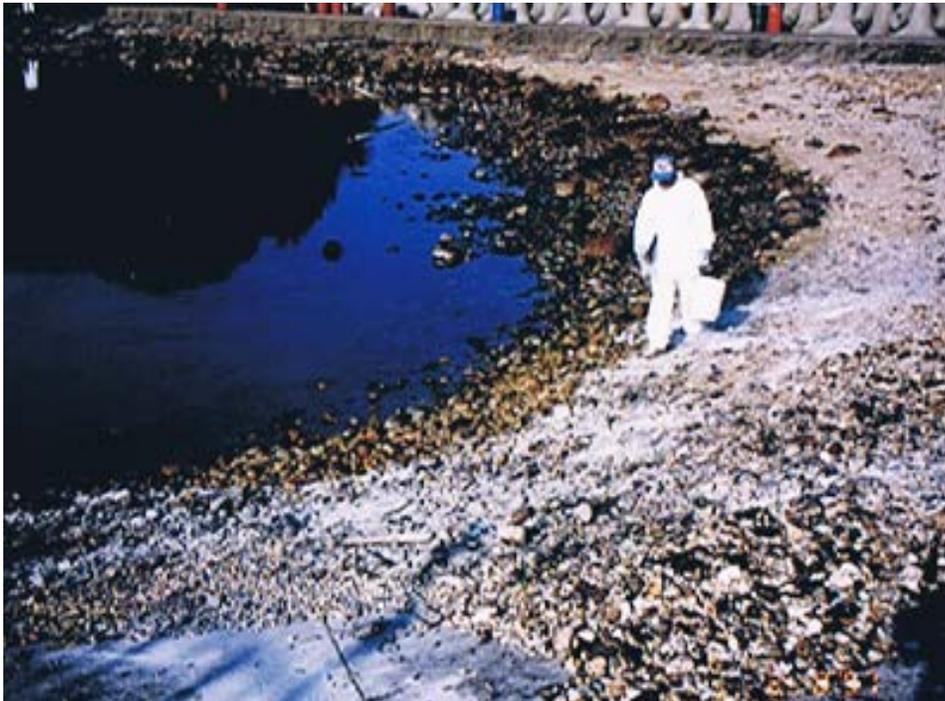
One area was highly impacted with both old dark tar-like weathered oil from the initial spill, and light brown platter-like tar patties from newly released oil.

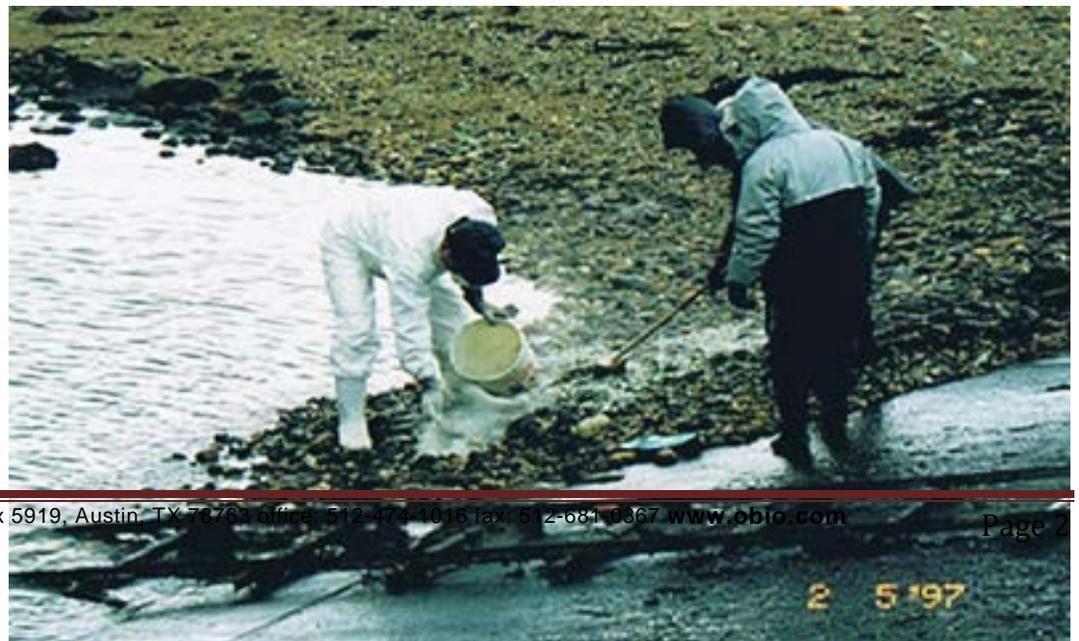
The weather along the coast was highly variable. The weather, during the project consisted of heavy seas and calm seas, rain, sleet, and sun. This affected the water level along the rocks and beaches. This change in energy along sand

beaches would erode the sand during high waves and then return the sand during calm weather. This impact could account for the observed burying of oil on the sand beaches.

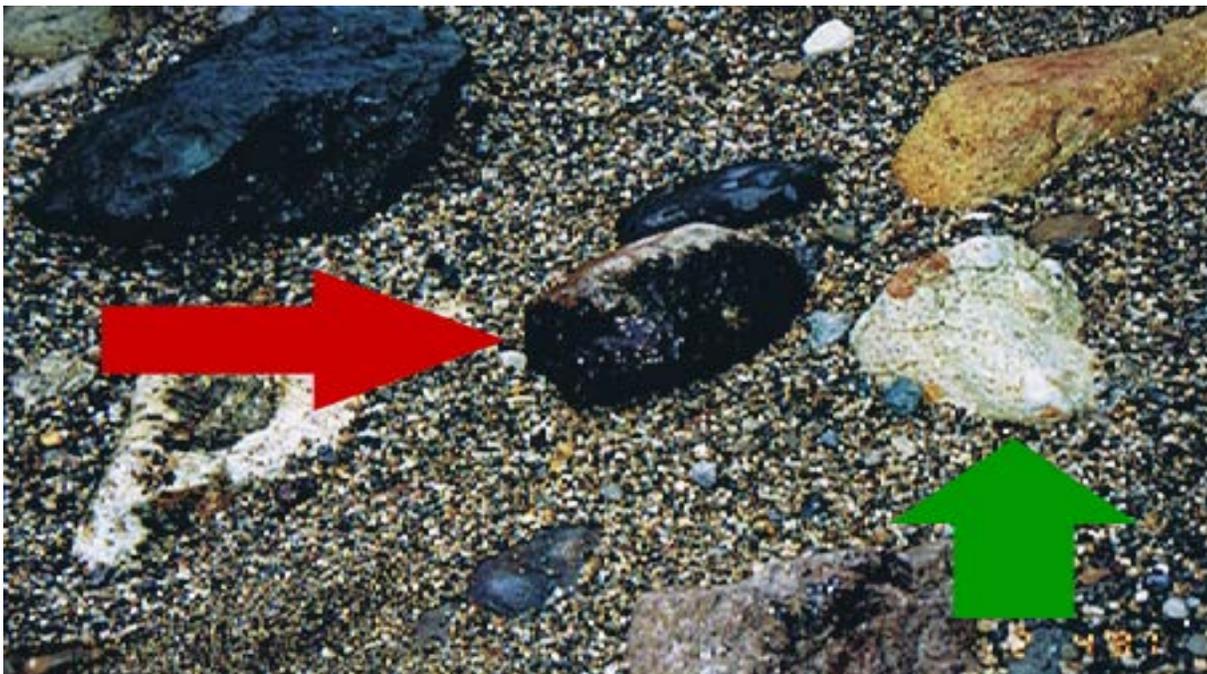
The Rock on the left hand side was left untreated and the rock on the right hand side was treated with

BioZorb®.

Prior to our visit Mr. Kono, Mr. Terakawa and Mr. Takai of the Fuji Packing Company of Osaka, had applied BioZorb to two areas, one on a breakwater and the other on rocks. Video taped daily coverage showed a reduction of thickness of the oil. Visual observation plus the video record confirmed that a reduction of oil was evident
